DEPARTMENT OF TRANSPORTATION

Quality Assurance and Source Inspection

Contract #: 04-0120F4Cty: SF/ALA Rte: 80 PM: 13.2/13.9File #: 69.28**WELDING INSPECTION REPORT****Resident Engineer:**Siegenthaler, Peter**Address:** 333 Burma Road**City:** Oakland, CA 94607**Report No:** WIR-017195**Date Inspected:** 07-Sep-2010**Project Name:** SAS Superstructure**OSM Arrival Time:** 700**Prime Contractor:** American Bridge/Fluor Enterprises, a JV**OSM Departure Time:** 1900**Contractor:** Zhenhua Port Machinery Company, Ltd (ZPMC), Changxing Island **Location:** Shanghai,China**CWI Name:** Mr.Tian Lei**CWI Present:** Yes No**Inspected CWI report:** Yes No N/A**Rod Oven in Use:** Yes No N/A**Electrode to specification:** Yes No N/A**Weld Procedures Followed:** Yes No N/A**Qualified Welders:** Yes No N/A**Verified Joint Fit-up:** Yes No N/A**Approved Drawings:** Yes No N/A**Approved WPS:** Yes No N/A**Delayed / Cancelled:** Yes No N/A**Bridge No:** 34-0006**Component:** OBG**Summary of Items Observed:**

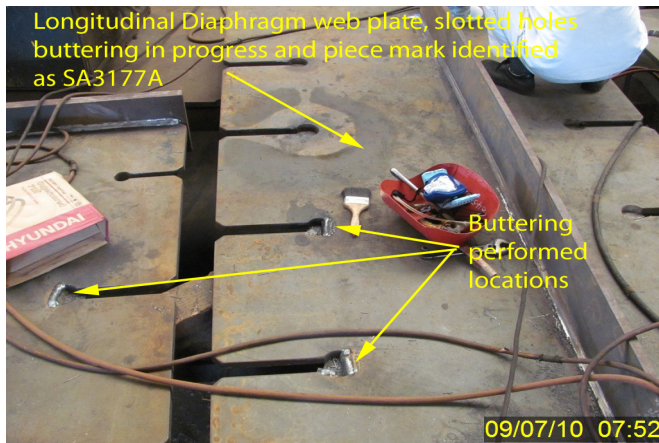
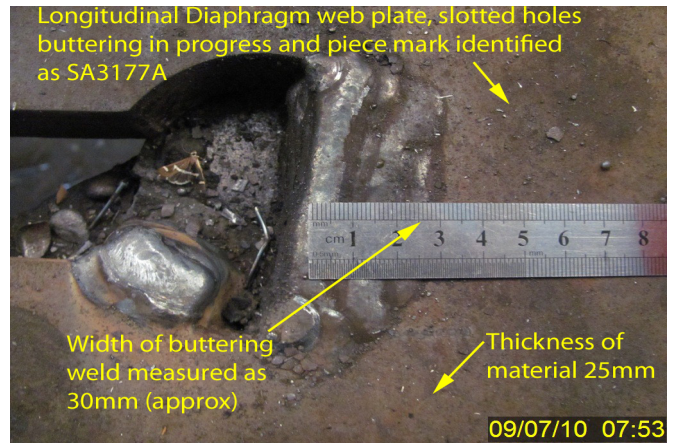
- Base metal repair being performed by ZPMC personnel without Engineers approval.
- The base metal repairs were being performed in the area of the cope holes at the top of the stiffener pass through slots in the web plates.
- ZPMC is building up the inside of all the cope areas to accommodate a drawing revision.
- Additionally ZPMC did not appear to prepare the edge of the material in a manner suitable for building up the edges as specified in ABF submittal 200.
- The members are identified as SA3177A, SA3177B, SA3179A, SA3179B, SA3178A, SA3178B, SA3158A and SA3177B.
- ZPMC personnel were performing the weld repairs per Weld Repair Report (WRR) B-WR14606.
- The Longitudinal Diaphragm components are located in Bay 2.

This Quality Assurance (QA) Inspector wrote an Incident Report for base metal repairs were being performed in the area of the cope holes at the top of the stiffener pass through slots in the web plates. Please reference the Incident Report # 04-0120F4_TL-15_B286_09-07-10_Buttering_Without_CWR. For further information, please see the attached pictures.
